**Attachment A: Digital Images**

May 28th, 2008

BOE Building 22<sup>nd</sup> Floor Fire Proofing Assessment  
Sacramento, CA

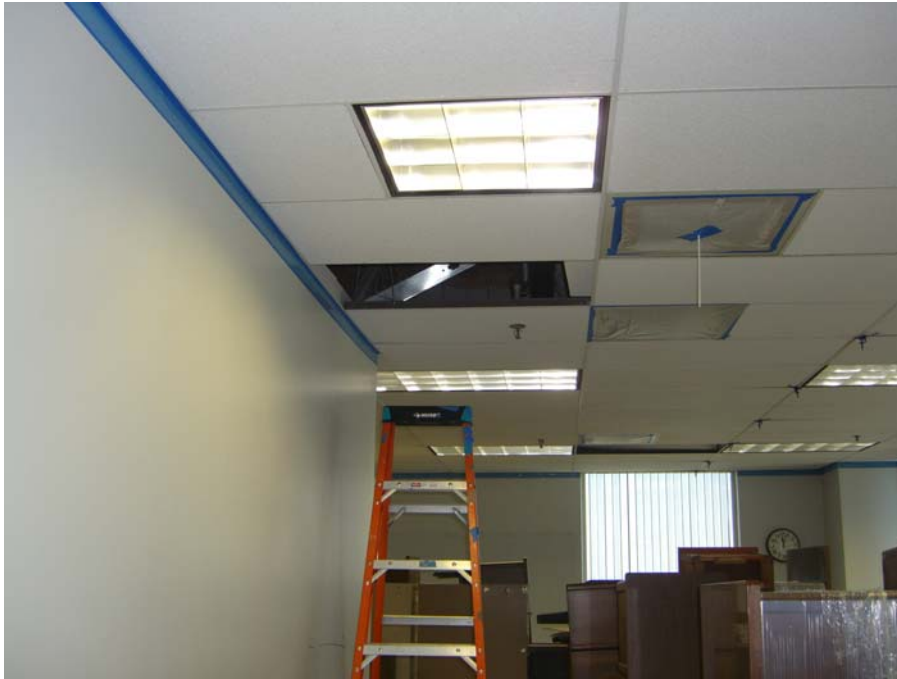
- 1) Image of ceiling access location on 22<sup>nd</sup> floor southeast side near office 2206 at the time of BioMax's assessment.

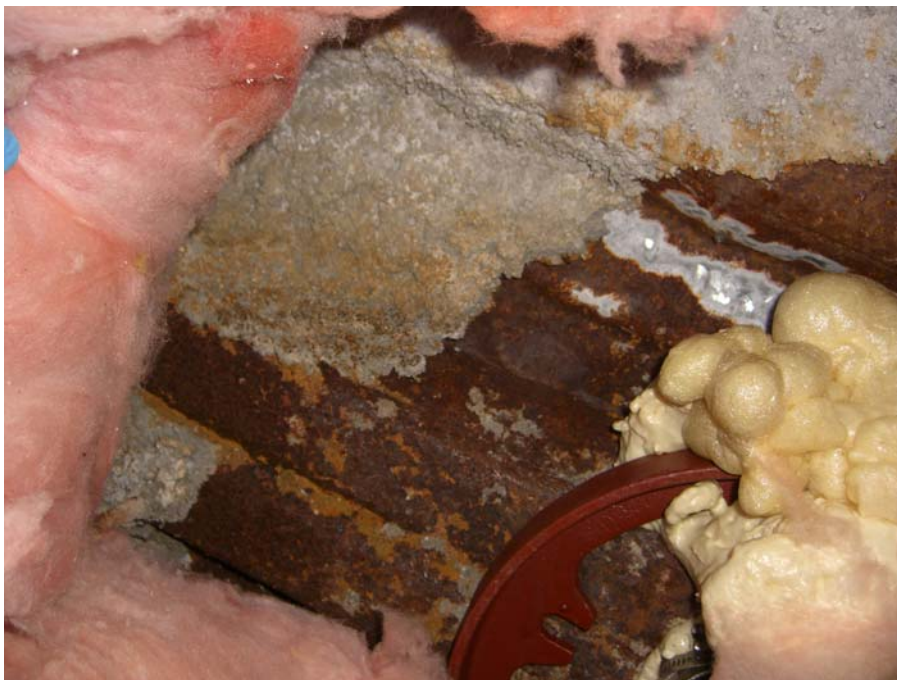
- 2) Image within ceiling plenum at deck drain penetration where advanced oxidation (rust) and Fireproofing (FP) material staining was evident. Sample B01 collected from FP material.

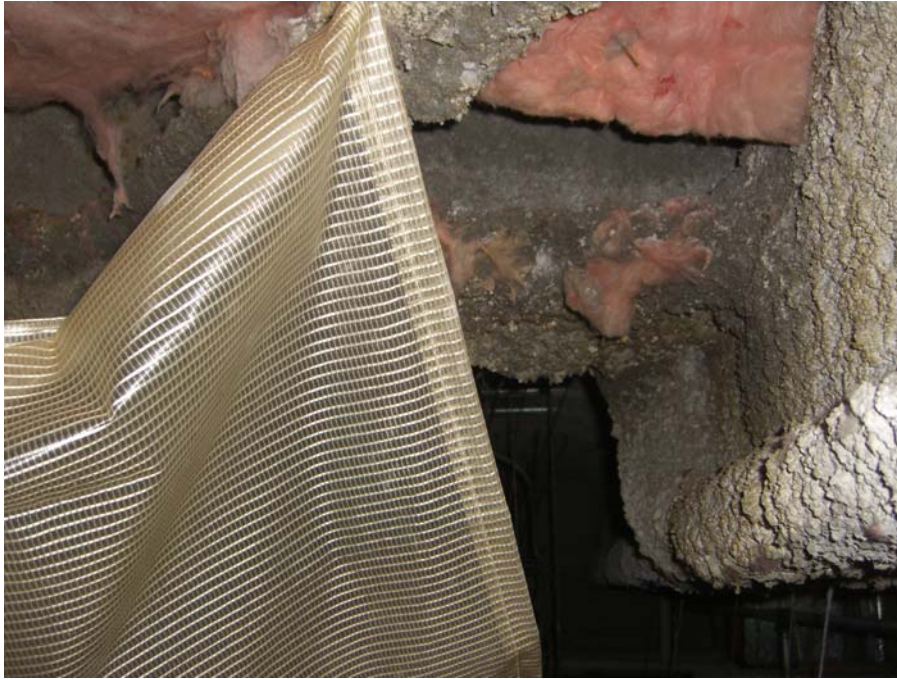
- 3) Image within plenum of DGS installed “Belly Pan” (BP) catch device. Staining present on FP material near BP. Sample B02 collected from stained FP material within noted plenum.

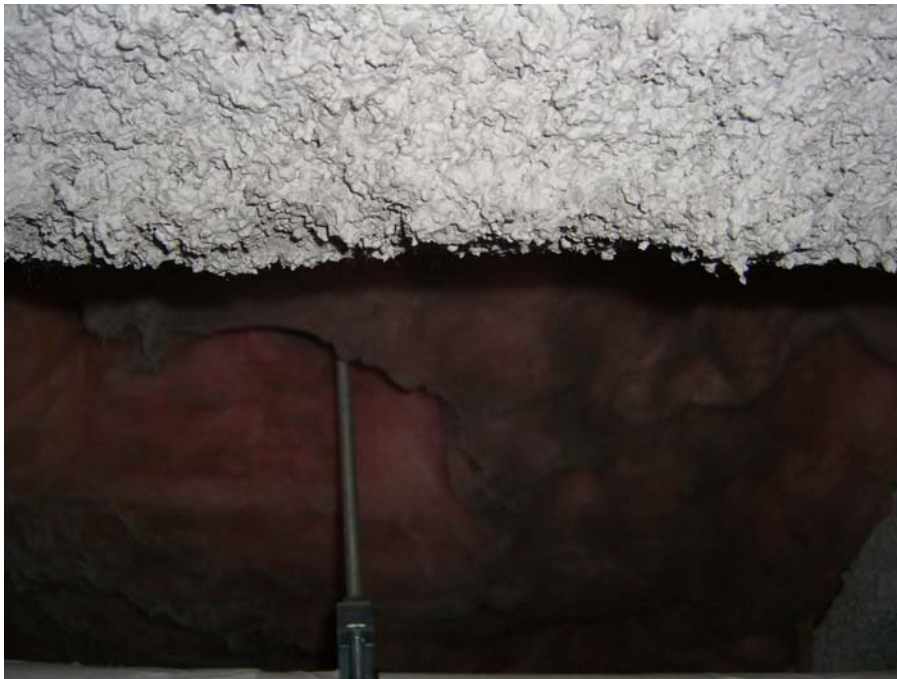
- 4) Close-up image of non-stained FP material sprayed upon metal structures. Sample B03 collected from such non-stained material within noted ceiling plenum.

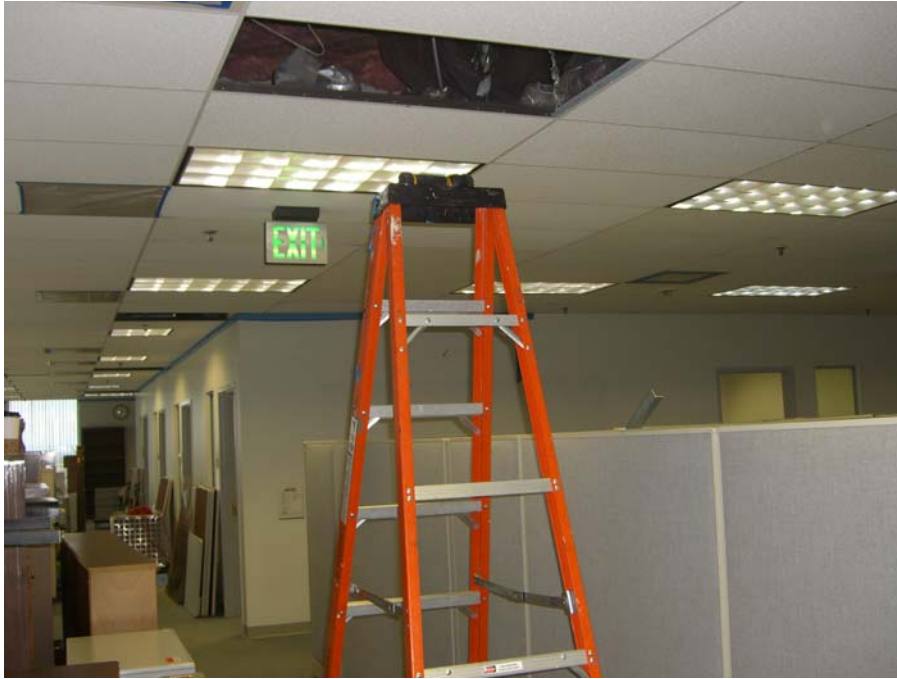
- 5) Image of ceiling access location near center cubicle area on southern side of 22<sup>nd</sup> floor at time of assessment.

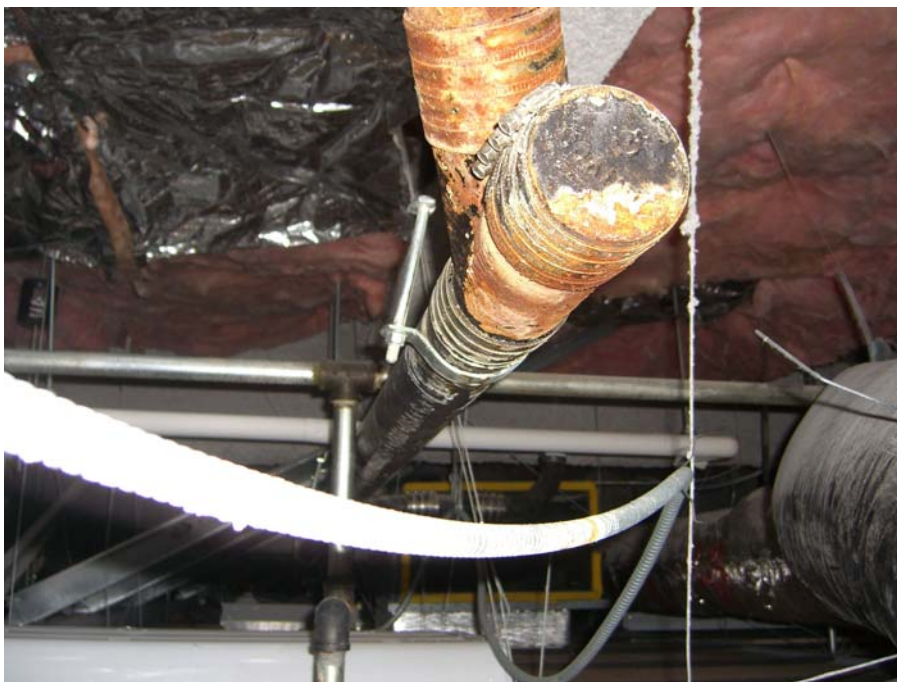
- 6) Image of Deck Drain (DD) plumbing with evidence of significant previous water leaking as indicated by oxidation and rust staining.

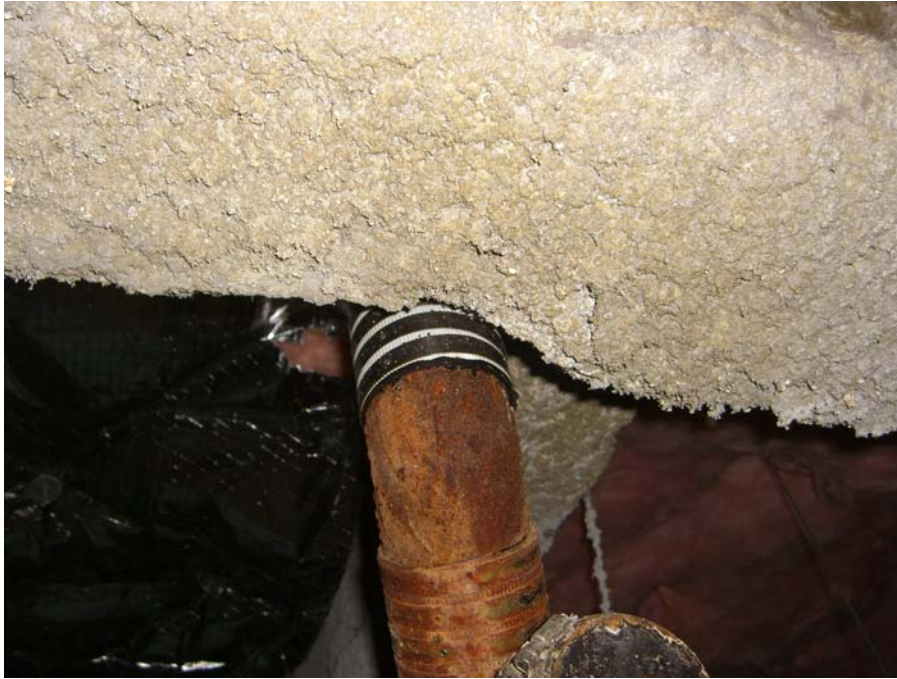
- 7) Close-up image of DD plumbing and adjacent FP material with staining present on exposed surfaces. Bulk sample B04 collected from stained FP material.

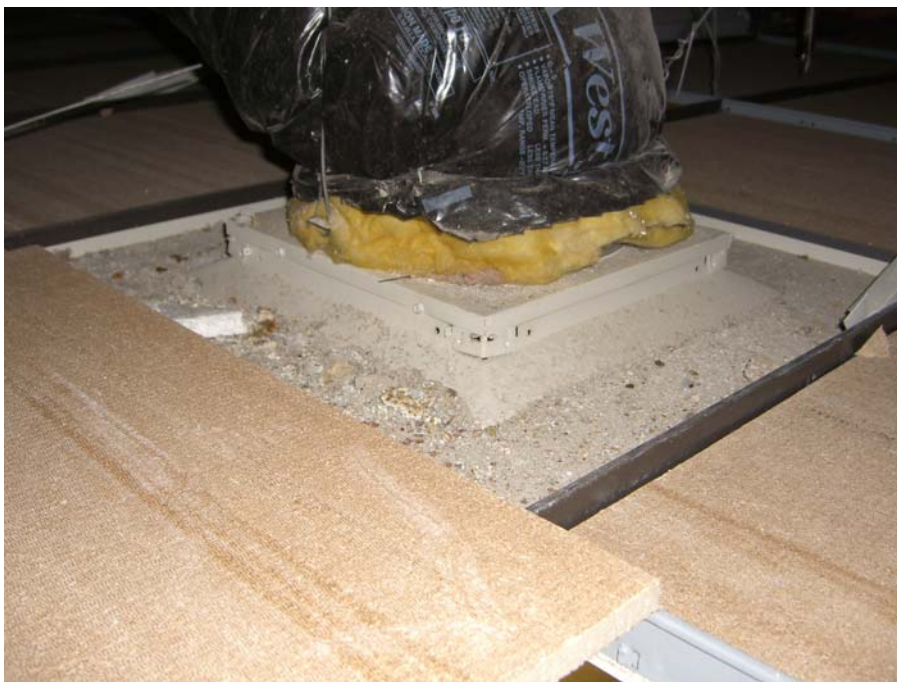
- 8) Image from noted ceiling plenum of HVAC supply register with significant visible debris build-up on metal flashing surface but not ceiling tile (CT) surface. Such evidence indicates likely replacement of CT and lack of cleanup following previous plenum activity.

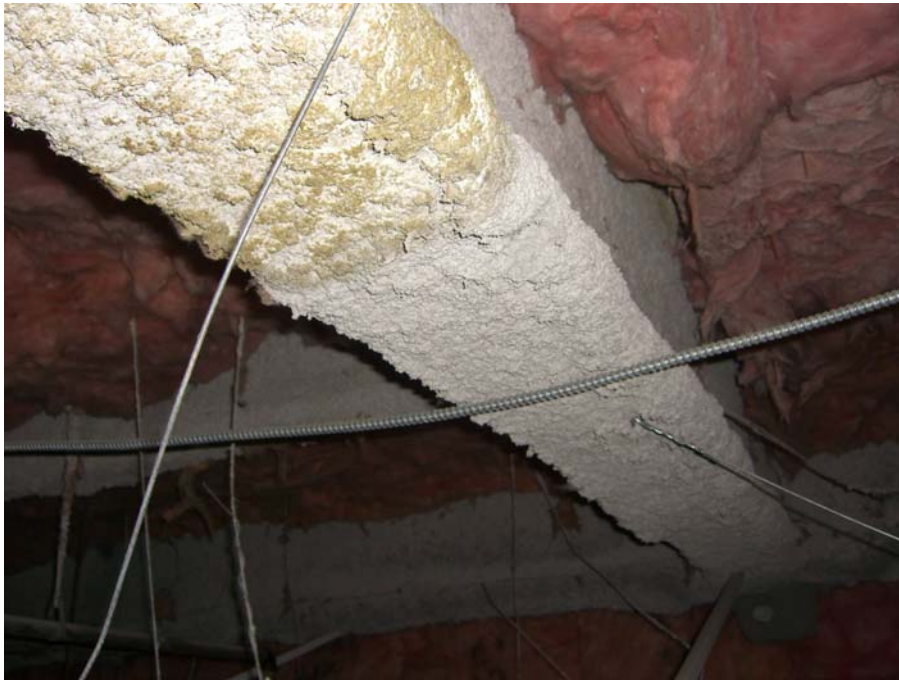
9) Image of limit and extent of stained material on FP within noted plenum area.

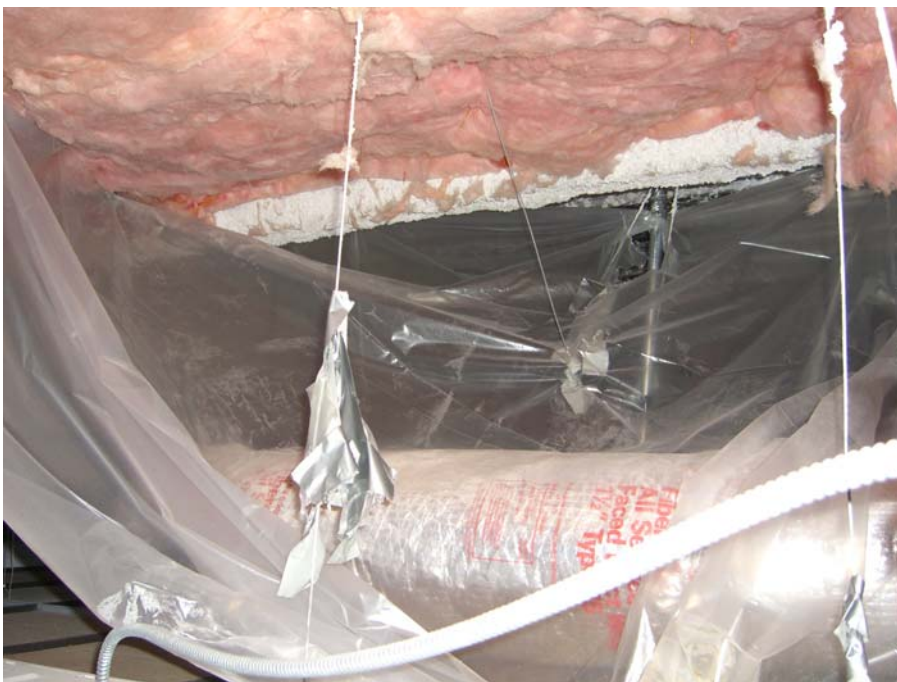
10) Image of abandoned BP device within noted ceiling plenum area adjacent to samples B04,5, and 6.

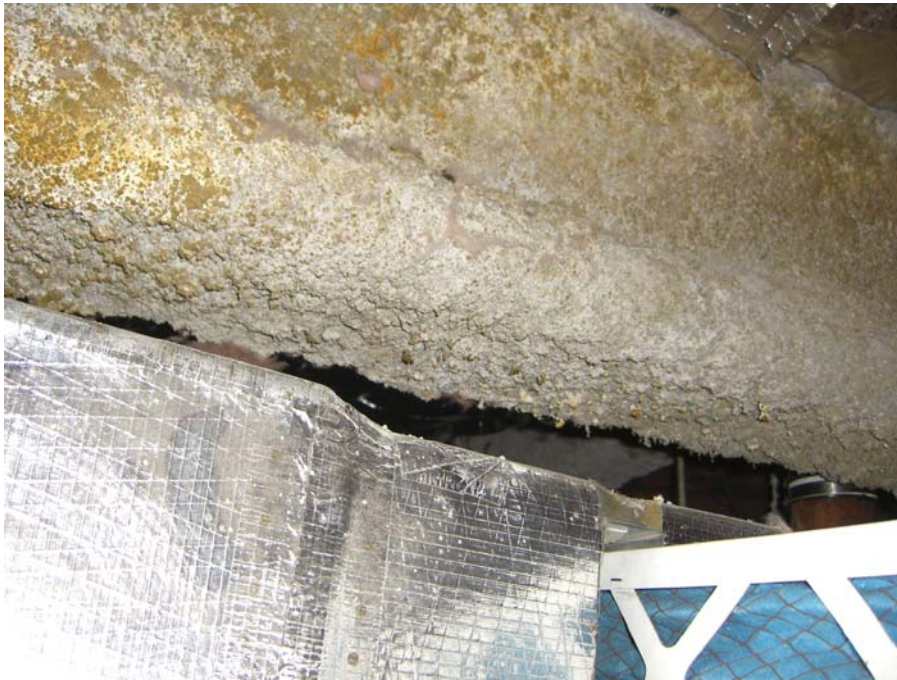
11) Image within noted ceiling plenum area of HVAC equipment adjacent to advanced staining of FP materials on metal support structures.

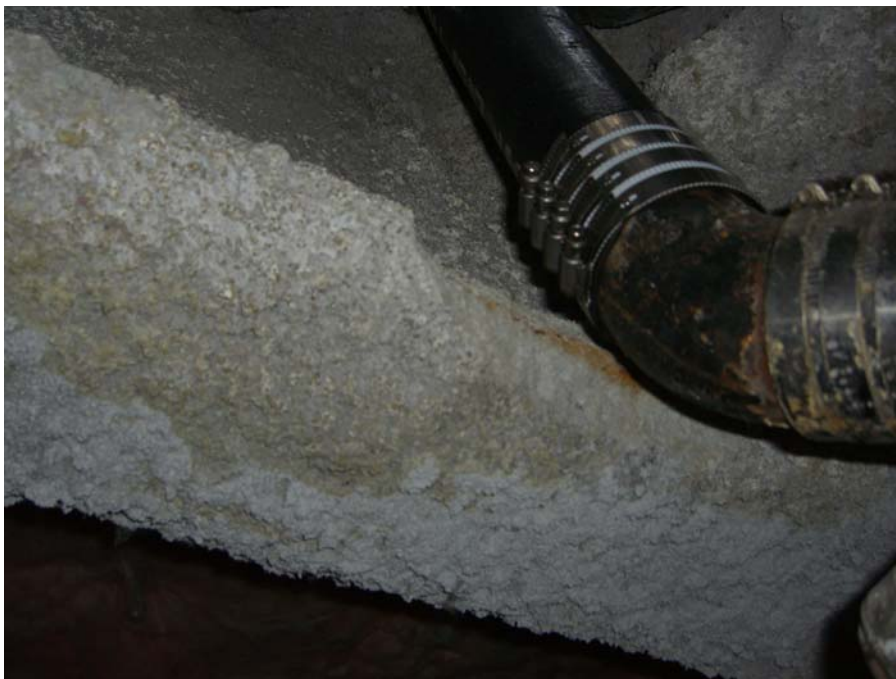
12) Additional image of deck drain plumbing with adjacent staining present on Fireproofing material sprayed upon metal support structures.

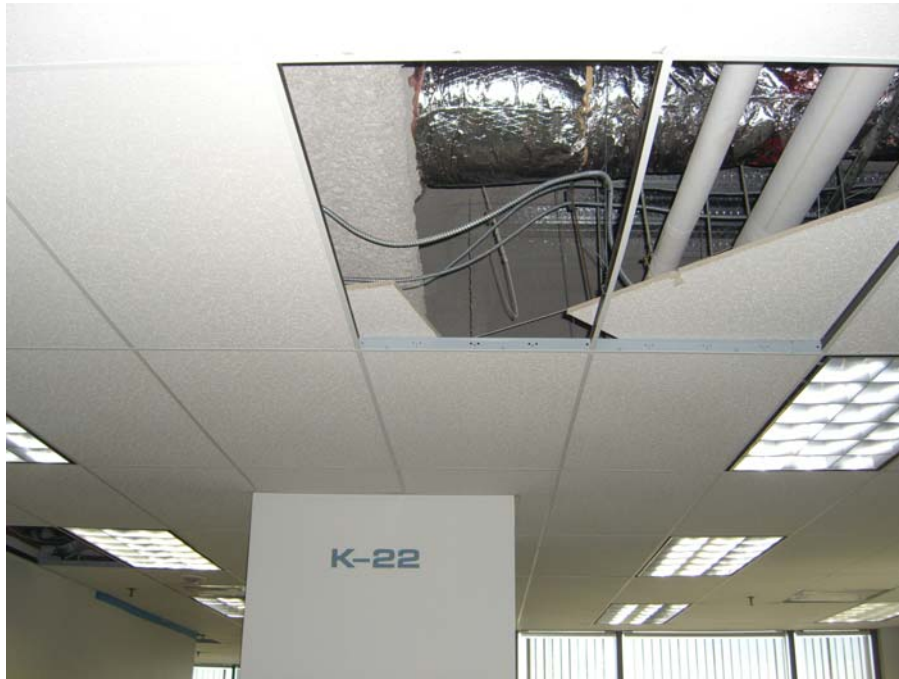
13) Image of 22<sup>nd</sup> Floor southern plenum location outside the deck/moisture impacted area wherein no significant staining indications were observed present on FP materials.

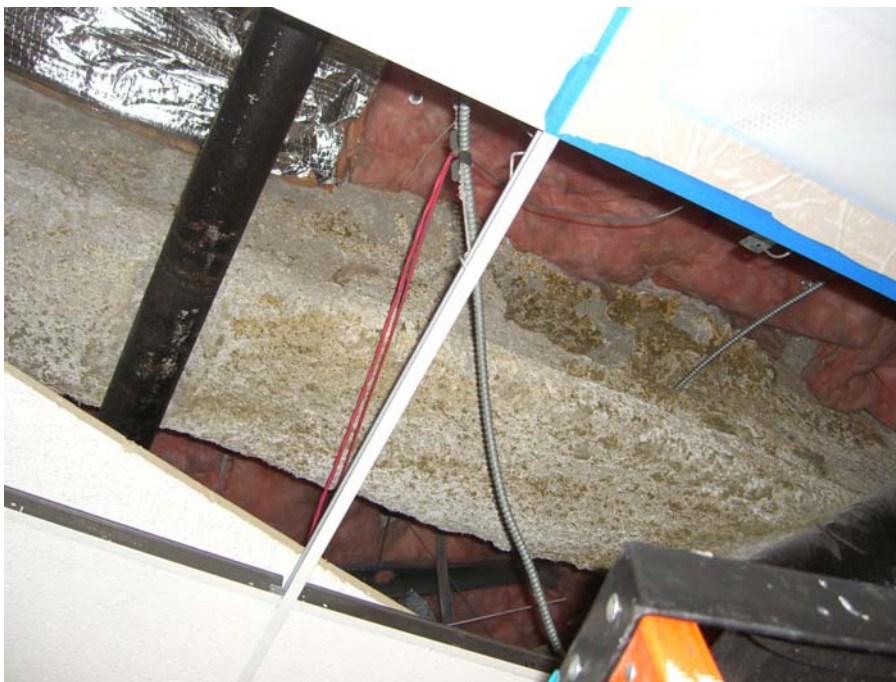
14) Image within plenum near 2215 where significant FP degradation and moisture staining were identified during assessment. Bulk material sample B10 and B11 were collected from such impacted materials.
